MERRIMACK RIVER BASIN  
WILTON, NEW HAMPSHIRE

SOUHEGAN RIVER WATERSHED  
DAM NO. 33  
NH 00265  
NHWRB 254.34

PHASE I INSPECTION REPORT  
NATIONAL DAM INSPECTION PROGRAM

AUGUST 1979

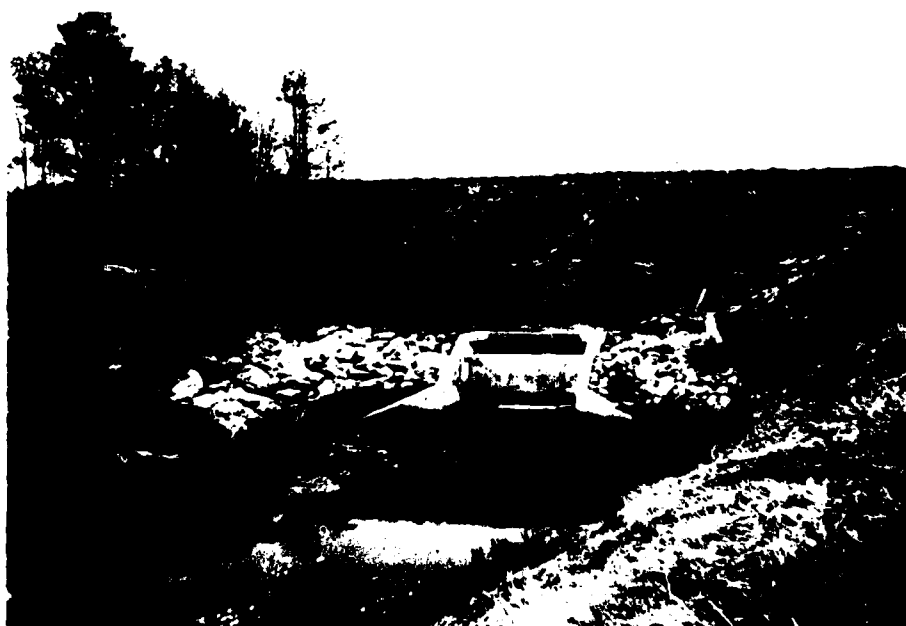
Overview photo of downstream slope

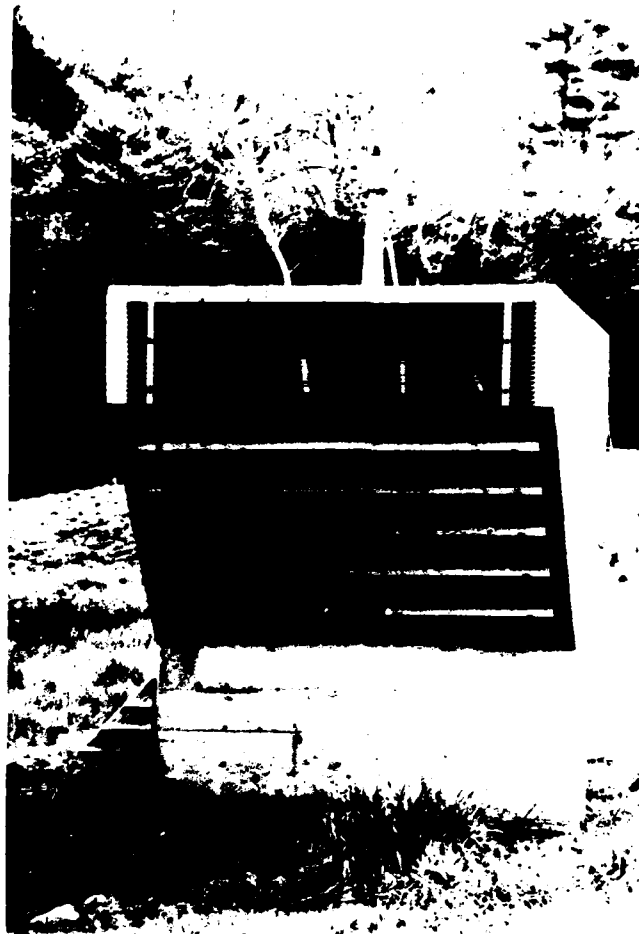
3. View of right side of drop inlet structure

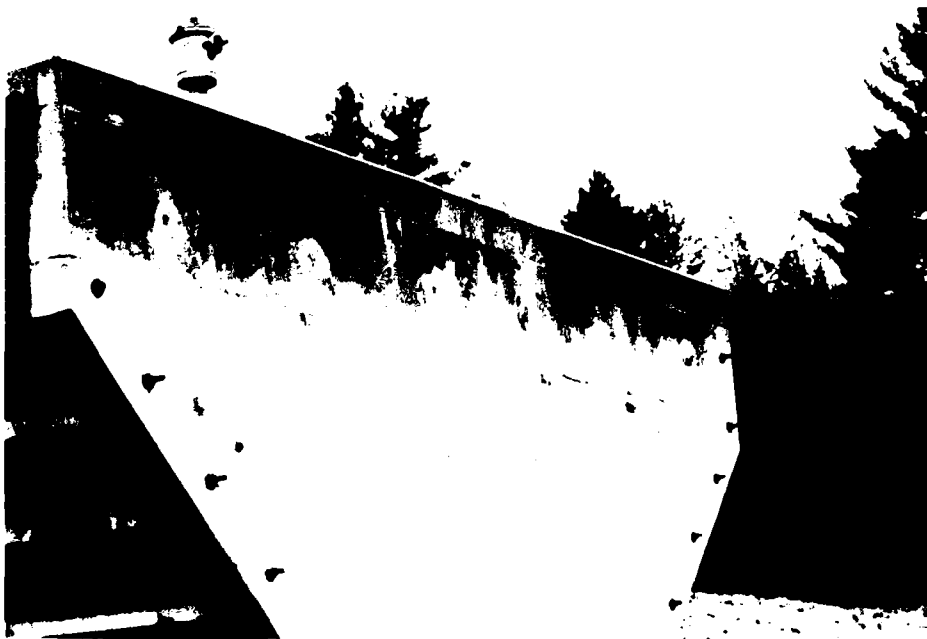
The structure is in good condition with some minor open horizontal construction joints and honeycombed concrete. The sluice gate bench stand is in good condition. The hand crank has been removed from the site to prevent unauthorized use. The trash racks are in good condition but are clogged with debris.

4. View showing joint erosion on drop inlet structure

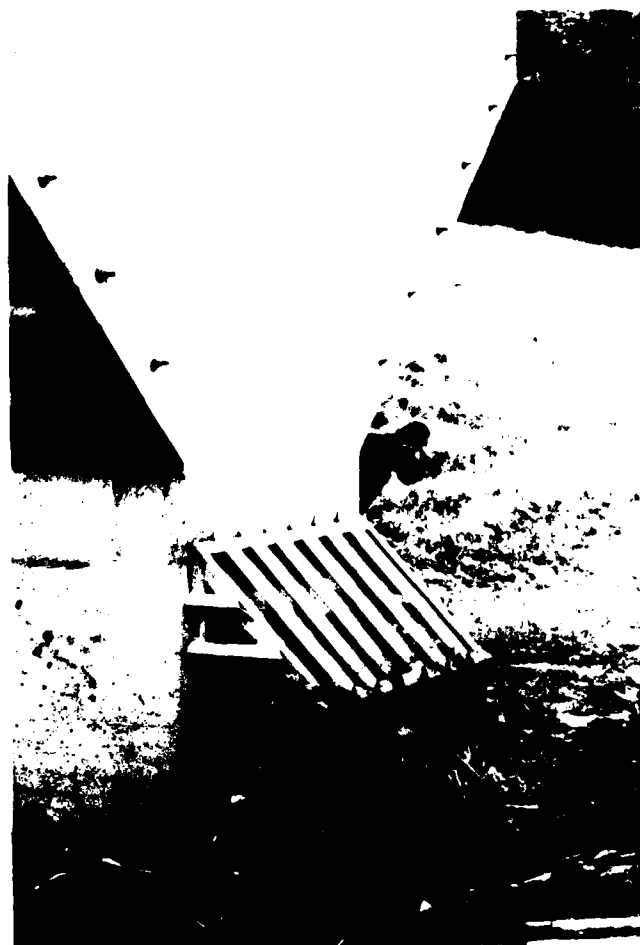
5. View of drop inlet structure showing debris in low stage trash rack

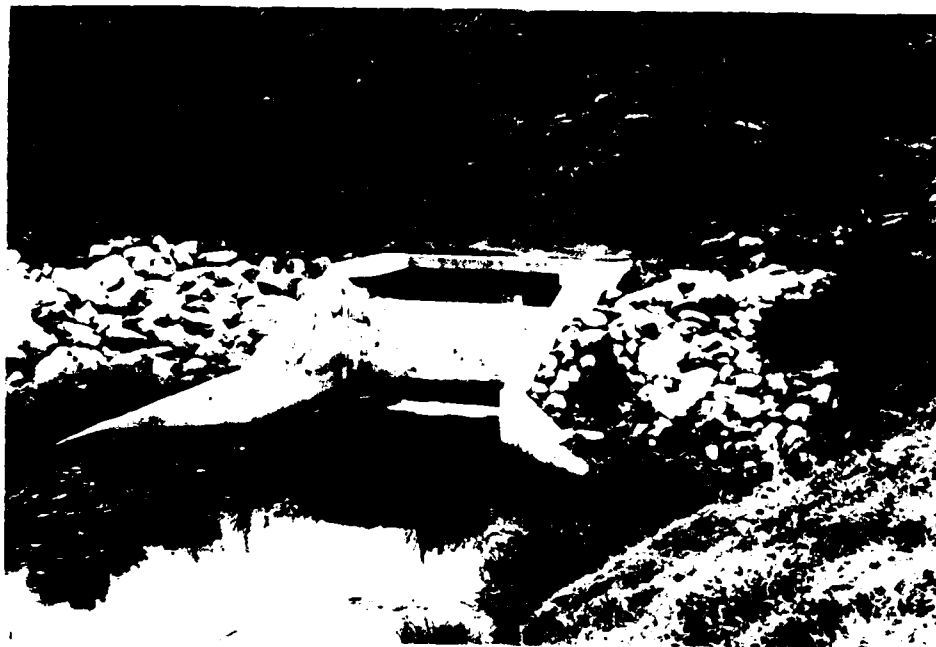
This structure is generally in good condition. There is some efflorescence on both ends of the top surface of the baffle wall and some minor erosion and staining of the headwall. There is no safety fence around this structure.

6. View of impact basin
